Sealing Leakage of Earth Dam by Concrete Diaphragm

Shen Chonggang and Jiang Guocheng

SYNOPSIS Some seriously cracked and leaked earth dams in China have been successfully strengthened by the cast-in-situ concrete diaphragm at or near the dam axis through the dam embankment. The diaphragm is enabled to seal the leakage through concentrated seepage path in the earthfill resulted from the large voids or the cracks in cohesive earthfill as well as the leakage through the alluvium in dam foundation. The effectiveness of this strengthening method depends on the correct determination of the major seepage channels. Serious longitudinal cracks have occurred in some dams during excavating the slurry trenches and pouring concrete into them owing to the hydraulic fracturing effect of the drilling fluid and liquid concrete. After some modification of the construction technique the strengthening work was carried out smoothly. The cracks were closed after completion of construction work and the contact between the earthfill and diaphragm was satisfactory.

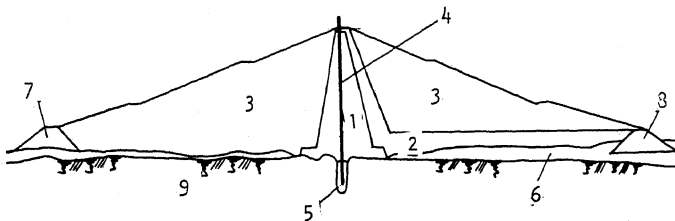
Fig. 2 The Cross Section of Zhaling Earth Dam

The construction work started in 1958, but was suspended for 8 years from 1962 to 1970. The earth dam was completed in 1971, and reservoir was filled in 1972. The clay core located at seriously weathered rock formation with developed fractures and faults, the water acceptance of which was greater than 10 Lugeon, even down to a depth of 50 m locally. Owing to the poor quality of the earth fills, the cracks appeared in construction stage, poor quality of the grout curtain, local big pore voids due to exist of weathered slate block etc., the upstream water level were limited to a lower level in the aspects of dam safety. A cast-in-situ concrete diaphragm within the clay core was accepted as the main strengthening measure. A row of holes within the diaphragm was provided at some sections to allow the additional grouting of foundation rock. The crest length of the diaphragm is about 600 m. It was divided into 60 trenches. The volume of concrete poured into the slurry trench was 38248 m³. The construction work started in December 1974 and ended in January 1978. Now the reservoir operated normally, which showed that the diaphragm appears to be very effective (Li Z.P., Wu X.Y., 1983).

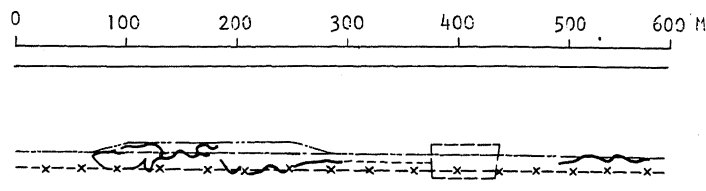
Fig. 4 Cracks at Dam Crest of Zhaling

At the beginning of the construction works at the dam crest of Zhaling earth dam, because of the lacking of practical experiences under such condition, the same principles as building diaphragms in dam foundation were adopted, such as filling the trench fully with drilling fluid, pouring concrete as quick as possible, excavating the trenches in primary and secondary order etc. This is the main reason for appearing serious cracks. In most cases leakage of slurry had taken place firstly, and followed by surface cracking, which had quickly been widened in the process of concrete pouring. The cracks were closed after set of concrete. The surface cracks had been developed along the axis of central core and throughout the whole dam crest, see Fig. 4. The dip angles of the cracks are very steep and accounted for more than $75^\circ - 80^\circ$ dip to upstream side. The cracks extended from dam crest down to the dam base. Their width varied, but not decreased with the depth, see Fig. 5.

The most serious cracks have a width of 25-30 cm and a differential settlement between the soil mass in both side of 20 - 25 cm. It must make sure if there will be a

sliding occurred or if the cracks will cross the central core. A borehole No. 10 had drilled at 1.4 m upstream from the surface crack. The drill cores with slurry or concrete had been got from depth 5.29-5.55, 5.62-5.90, 6.50-6.64, 16.29-17.97, 20.1-33.45 m from dam crest. An additional borehole No. 12, located at 1.0 m upstream from borehole No. 10, hadn't found out any cracks filled with slurry. It showed that the cracks extended downward nearly vertically. Not only slurry, but also concrete had filled the cracks, which showed that the cracks were expanded during concrete pouring.

There are two different ways to approaching the mechanisms of forming cracks. The first is reopening and expanding of the minor fractures already existed. The second is newly fractured under the pressure of slurry and liquid concrete, known as the phenomena of hydraulic fracturing. The latter seems to be correct for the following reasons:

1. The fracturing pattern of the cracks. All the cracks are nearly perpendicular to the direction of minor principal stress and meander the dam axis. They extended downward to the dam base vertically. The width of the cracks are variable, but no tendency to decrease with depth.

1. Control the slurry level in the trench not higher than the bottom of the guide wall at top end of the trench and the density of the slurry not exceed 1.15 g/cm^3 in order to reduce the fluid pressure;

2. Control the pouring speed not exceed 1 m/hr. and timely pumping out the slurry replaced by concrete in order to reduce the combined fluid pressure due to both liquid concrete and slurry.

3. Trench excavation was completed by three orders, e.i. two excavating trenches apart from each other at least a distance of two trench length.

4. At the moment of leaking slurry or concrete, the construction works were stopped temporarily until the leakage was ceased.
